1. Introduction

2. Test Setup

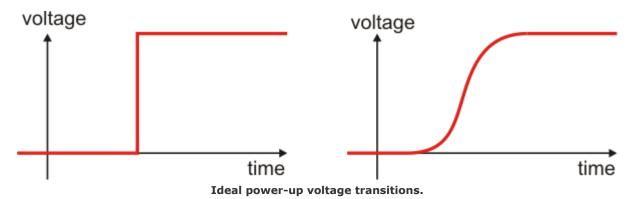
Powering up can be one of the most dangerous events an electrical system endures: current rushes in as the circuit passes through voltages that are outside of the normal operating range and as different sub-circuits begin functioning sooner than others. Those without much electronics experience might imagine an instantaneous change in voltage or at least a gradual, monotonic rise at the power node:

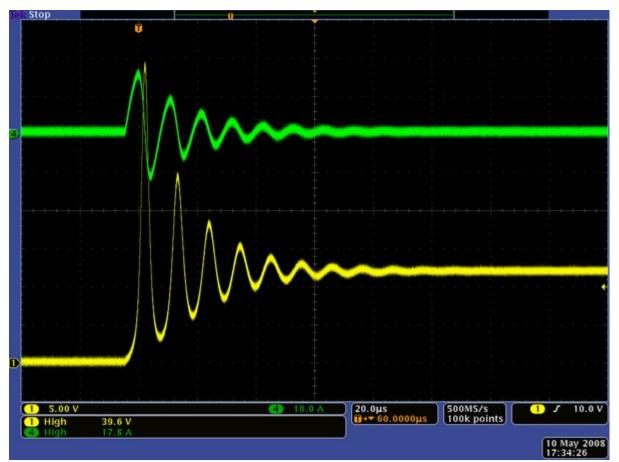
As with many unexpected problems that we encounter in electronics, the causes of the destructive spikes we are exploring here are the non-negligible parasitic elements of the components we try to idealize. The power supply and power leads can have a relatively large inductance (L) that causes a large electromagnetic energy buildup when charging a capacitor (C). That energy is there in the magnetic field around the wires even after the capacitor voltage has reached the power supply voltage, and the collapsing magnetic field continues delivering current into the capacitor, causing its voltage to continue rising. That voltage can rise to several times the power supply voltage before the magnetic field is exhausted, which then causes the current to flow in the other direction as the capacitor discharges back into the power supply. This charging and discharging of the capacitor can happen a few times before the system stabilizes, and the frequency of the oscillations is determined by the inductance and capacitance (L and C).

Oscilloscope capture showing LC spike voltage (yellow) and current (green).

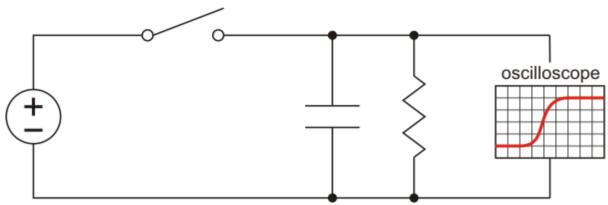
The circuit for this test consists of just three main components: a power supply, a switch, and a capacitor. We observe the voltage across the capacitor with an oscilloscope to see the start-up transients to which a circuit, represented by a load resistor, would be exposed if it were powered this way. A schematic diagram of the test circuit is shown below:

Schematic diagram for using an oscilloscope to measure the voltage across a capacitor after a switch is closed.

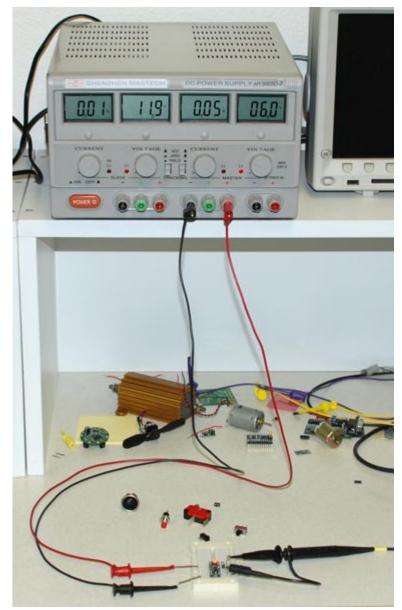
With a representative capacitor selected, we tested a typical setup with a bench power supply and power clips:

LC spike test setup showing bench power supply with 36" power leads.

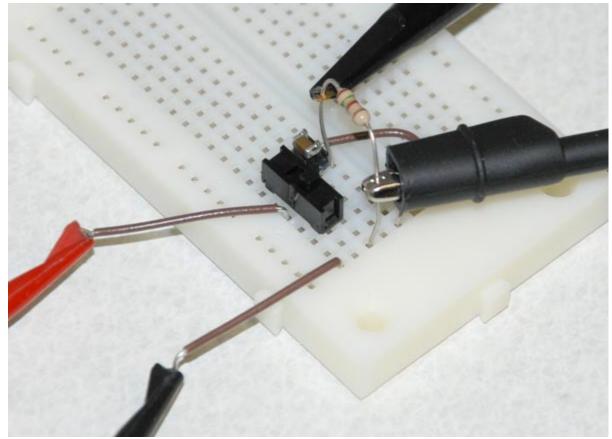
LC spike test setup with slide switch.

The power supply was set to 12 V. The test clips are 20 AWG and 36" long, which are typical of what might be used in most electronics prototyping benches.

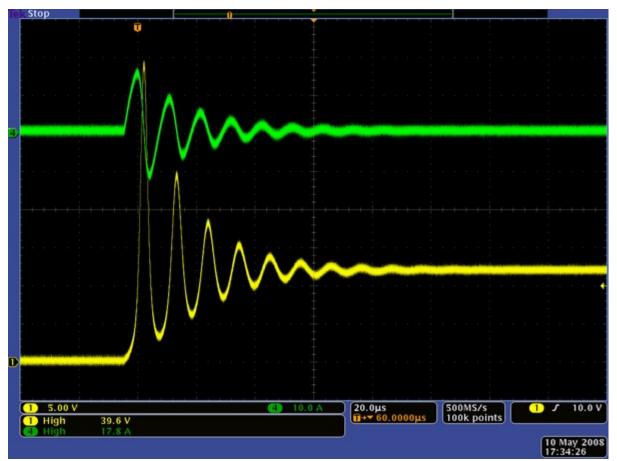
Oscilloscope capture showing LC spike voltage (yellow) and current (green).

There are several noteworthy features to the above traces. Most striking is the magnitude of the first spike, which at almost 40 V is more than three times the 12 V we were attempting to apply to the circuit. We also see that there are four peaks above 15 V. The potentially destructive implications of the LC transients are clear: 12 V might seem like a safe voltage to apply to a device with a maximum voltage rating of 15 V, but the casual application of the 12 V repeatedly subjects the device to voltages outside the allowable range.

We also see that the frequency of the oscillations is just under 100 kHz, which with a capacitance of approximately 9 uF indicates that the wire inductance is a few hundred nH, which is consistent with what we would expect for the 36" leads.

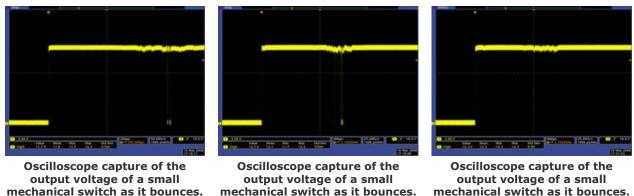
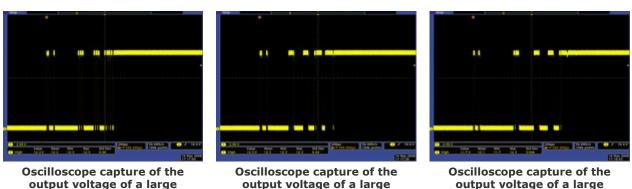
mechanical switch as it bounces. mechanical switch as it bounces. In our power switch and LC spike context, however, each additional bounce of the switch contacts can unleash a fresh set of spikes, increasing the likelihood of destroying the circuit we're turning on. The problem usually gets worse with physically larger switches that are necessary for higher-power applications since the larger switches tend to bounce

mechanical switch as it bounces.

output voltage of a large mechanical switch as it bounces.

To isolate the switch bouncing effects from the LC effects, the switch bouncing screen shots above were taken without a capacitor. Once we put the capacitor back into the circuit, we can see the potentially devastating combined effect of the bouncing and the LC spikes:

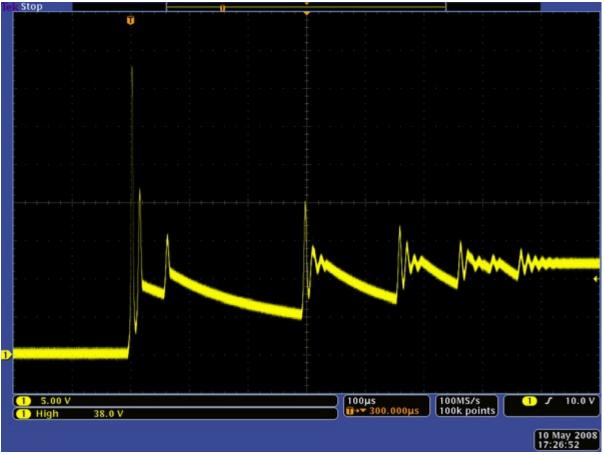
Oscilloscope capture of the LC voltage spikes caused by a large bouncing mechanical switch.

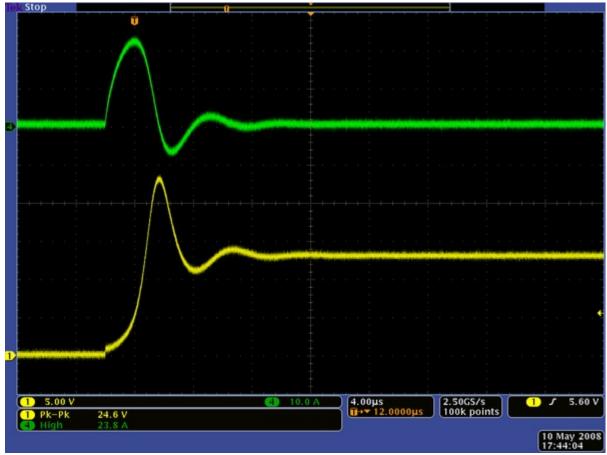
Oscilloscope capture of the voltage (yellow) and current (green) when using a battery with short leads.

The charged battery voltage is over 13 V, so the 25 V peak we see here is now less than double the voltage we're intending to apply. It could still destroy some components, but there are many more that can survive 25 V than can survive 40 V.

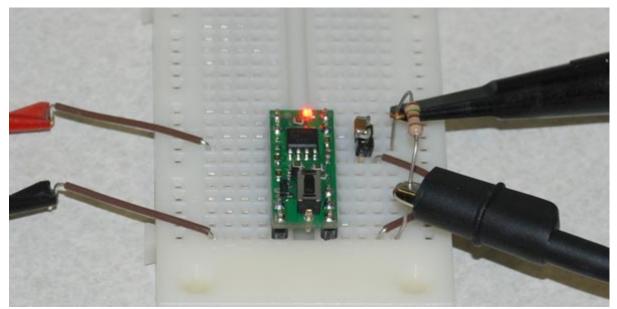
However, adding resistance can be very undesirable in high-power applications. One option in such cases is to replace the instantaneous connection of a mechanical switch with the more gradual transition offered by an electronic switch, such as a MOSFET. We tested this approach with the **Pololu pushbutton power switch [http://www.pololu.com/catalog/ product/750]**, which is based on a MOSFET:

LC spike test setup close-up showing Pololu pushbutton power switch.

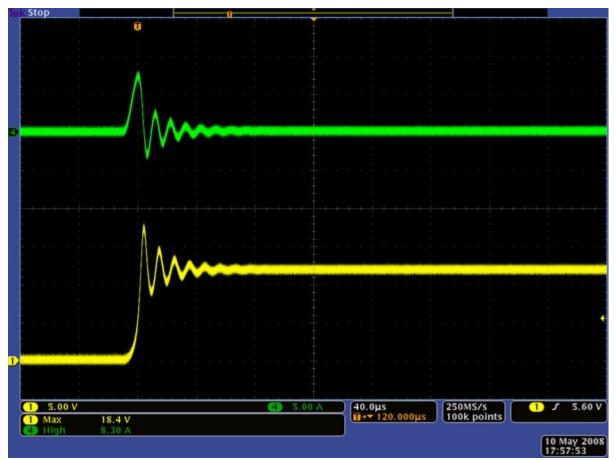
The MOSFET does add a bit of resistance (typically around 0.01 ohms), but the important factor is the MOSFET's gradual transition from non-conductive to conductive. With the mechanical switch replaced by a MOSFET, the 40-volt peak we saw was reduced to under 20 V:

Oscilloscope capture of voltage (yellow) and current (green) when using the Pololu pushbutton power switch and bench power supply.

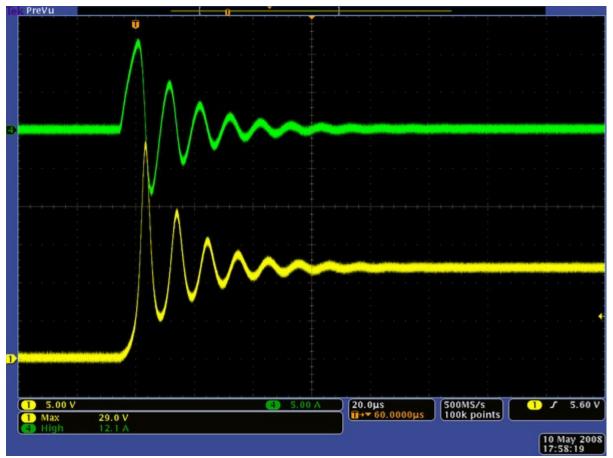
It's worth noting that the circuit in the Pololu pushbutton power switch is not especially designed to turn on slowly, so an electronic-switch approach could completely eliminate the transient with a slower turn-on time. In the case of the Pololu pushbutton power switch, double-clicking quickly enough when starting in the on state (i.e. turning off and immediately turning back on) can cause the second turn on to be faster, leading to results more similar to those with the mechanical switch:

Oscilloscope capture of voltage (yellow) and current (green) when "double-clicking" a Pololu pushbutton power switch connected to a bench power supply.

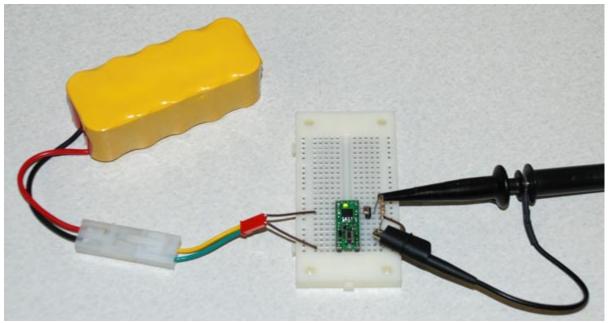
We then combined the MOSFET-based approach with the reduced wire inductance of the battery test:

LC spike test setup with battery pack and Pololu pushbutton power switch.

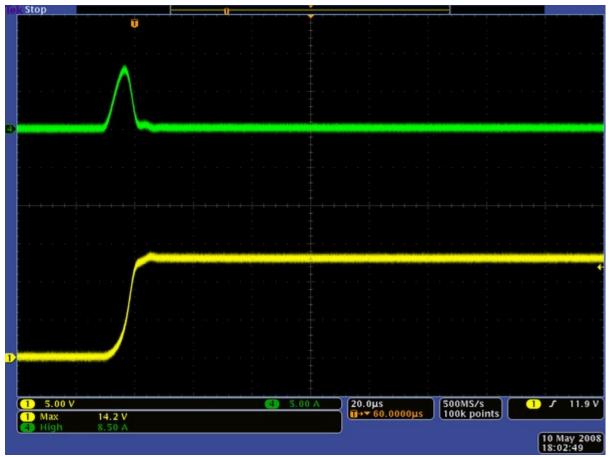
After seeing so many spikes, the near perfection of the transition is quite refreshing:

Oscilloscope capture of voltage (yellow) and current (green) when using the Pololu pushbutton power switch and a battery.

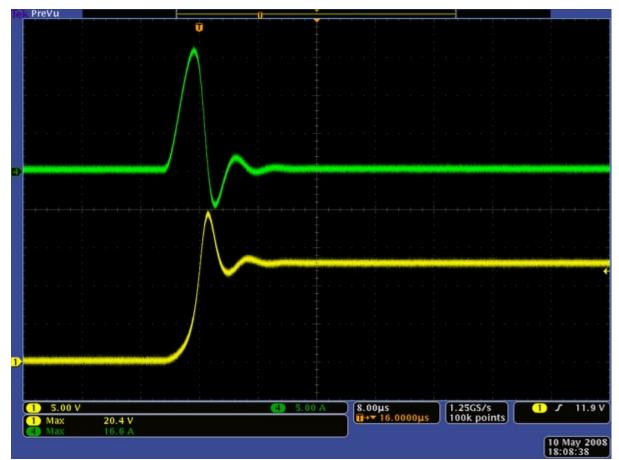
In the case of the Pololu pushbutton power switch, there is still the unfortunate (in this application) double-click possibility: after many attempts at getting the right timing, we were still able to catch some spikes, though they were much less severe than the 40 V peaks we saw earlier:

Oscilloscope capture of voltage (yellow) and current (green) when "double-clicking" a Pololu pushbutton power switch connected to a battery.

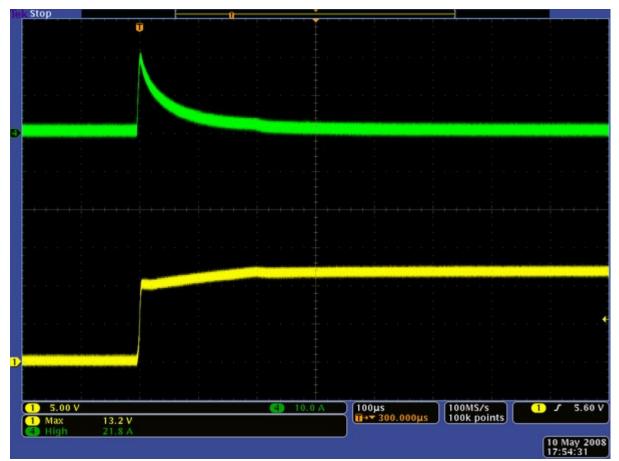
We introduced the LC transient problem as being unique to ceramic capacitors with low equivalent series resistance (ESR). One particularly straightforward solution to the problem is to add a **large capacitor with high ESR [http://www.pololu.com/catalog/product/882]** to the circuit. The large capacitor prevents the voltage from changing quite as quickly, yet its high ESR prevents it from drawing as much initial current. Here is the result when we added a 100 uF electrolytic capacitor across our 10 uF test capacitor:

Oscilloscope capture of voltage (yellow) and current (green) when a 100 uF electrolytic capacitor is added in parallel with the ceramic capacitor.
