# **Understanding Destructive LC Voltage Spikes**

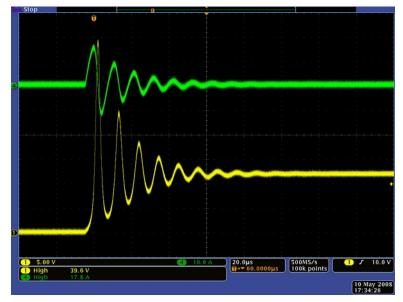
Oscilloscope capture showing LC spike voltage (yellow) and current (green).

As with many unexpected problems that we encounter in electronics, the causes of the destructive spikes we are exploring here are the non-negligible parasitic elements of the components we try to idealize. The power supply and power leads can have a relatively large inductance (L) that causes a large electromagnetic energy buildup when charging a capacitor (C). That energy is there in the magnetic field around the wires even after the capacitor voltage has reached the power supply voltage, and the collapsing magnetic field continues delivering current into the capacitor, causing its voltage to continue rising. That voltage can rise to several times the power supply voltage before the magnetic field is exhausted, which then causes the current to flow in the other direction as the capacitor discharges back into the power supply. This charging and discharging of the capacitor can happen a few times before the system stabilizes, and the frequency of the oscillations is determined by the inductance and capacitance (L and C).

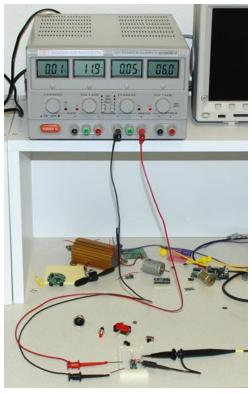
LC spike test setup showing bench power supply with 36" power leads.

We conducted our tests both with mechanical switches and with the **Pololu pushbutton power switch** [http://www.pololu.com/catalog/product/750], and we later replaced the power supply with a battery and shorter leads.

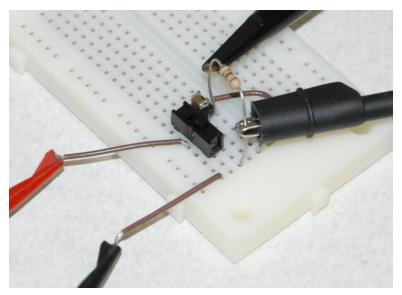
LC spike test setup with slide switch.

The power supply was set to 12 V. The test clips are 20 AWG and 36" long, which are typical of what might be used in most electronics prototyping benches.

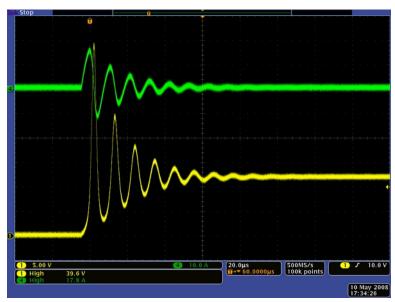
Oscilloscope capture showing LC spike voltage (yellow) and current (green).

There are several noteworthy features to the above traces. Most striking is the magnitude of the first spike, which at almost 40 V is more than three times the 12 V we were attempting to apply to the circuit. We also see that there are

four peaks above 15 V. The potentially destructive implications of the LC transients are clear: 12 V might seem like a safe voltage to apply to a device with a maximum voltage rating of 15 V, but the casual application of the 12 V repeatedly subjects the device to voltages outside the allowable range.

We also see that the frequency of the oscillations is just under 100 kHz, which with a capacitance of approximately 9 uF indicates that the wire inductance is a few hundred nH, which is consistent with what we would expect for the 36" leads.

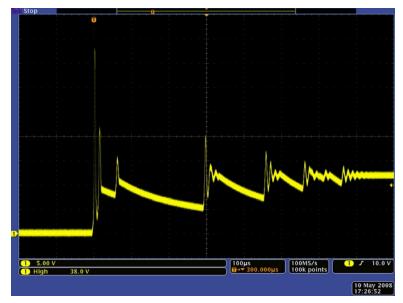
To isolate the switch bouncing effects from the LC effects, the switch bouncing screen shots above were taken without a capacitor. Once we put the capacitor back into the circuit, we can see the potentially devastating combined effect of the bouncing and the LC spikes:

Oscilloscope capture of the LC voltage spikes caused by a large bouncing mechanical switch.

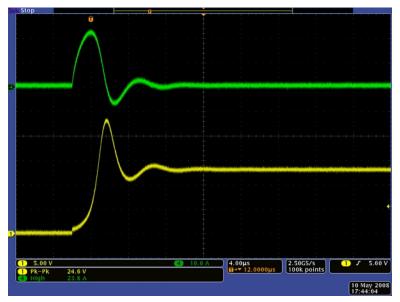
Oscilloscope capture of the voltage (yellow) and current (green) when using a battery with short leads.

The charged battery voltage is over 13 V, so the 25 V peak we see here is now less than double the voltage we're intending to apply. It could still destroy some components, but there are many more that can survive 25 V than can survive 40 V.

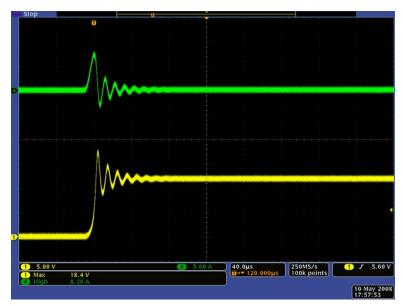
The MOSFET does add a bit of resistance (typically around 0.01 ohms), but the important factor is the MOSFET's gradual transition from non-conductive to conductive. With the mechanical switch replaced by a MOSFET, the 40-volt peak we saw was reduced to under 20 V:

Oscilloscope capture of voltage (yellow) and current (green) when using the Pololu pushbutton power switch and bench power supply.

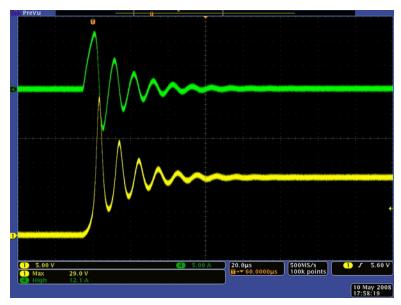
It's worth noting that the circuit in the Pololu pushbutton power switch is not especially designed to turn on slowly, so an electronic-switch approach could completely eliminate the transient with a slower turn-on time. In the case of the Pololu pushbutton power switch, double-clicking quickly enough when starting in the on state (i.e. turning off and immediately turning back on) can cause the second turn on to be faster, leading to results more similar to those with the mechanical switch:

Oscilloscope capture of voltage (yellow) and current (green) when "double-clicking" a Pololu pushbutton power switch connected to a bench power supply.

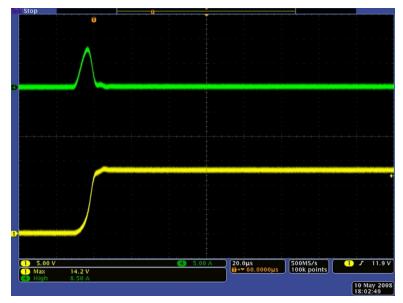
After seeing so many spikes, the near perfection of the transition is quite refreshing:

Oscilloscope capture of voltage (yellow) and current (green) when using the Pololu pushbutton power switch and a battery.

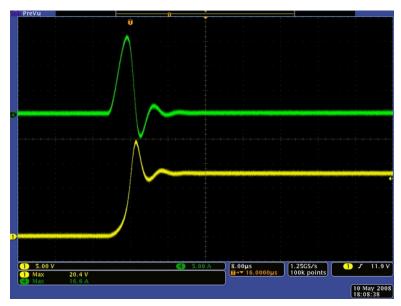
In the case of the Pololu pushbutton power switch, there is still the unfortunate (in this application) double-click possibility: after many attempts at getting the right timing, we were still able to catch some spikes, though they were much less severe than the 40 V peaks we saw earlier:

Oscilloscope capture of voltage (yellow) and current (green) when "double-clicking" a Pololu pushbutton power switch connected to a battery.

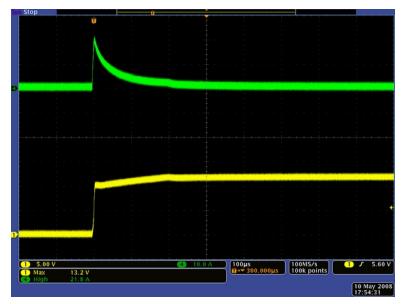
We introduced the LC transient problem as being unique to ceramic capacitors with low equivalent series resistance (ESR). One particularly straightforward solution to the problem is to add a large capacitor with high ESR to the circuit. The large capacitor prevents the voltage from changing quite as quickly, yet its high ESR prevents it from drawing as much initial current. Here is the result when we added a 100 uF electrolytic capacitor across our 10 uF test capacitor:

Oscilloscope capture of voltage (yellow) and current (green) when a 100 uF electrolytic capacitor is added in parallel with the ceramic capacitor.
